MILL DAM

PHASE I INSPECTION REPORT

NATIONAL DAM SAFETY PROGRAM

NJ 00060

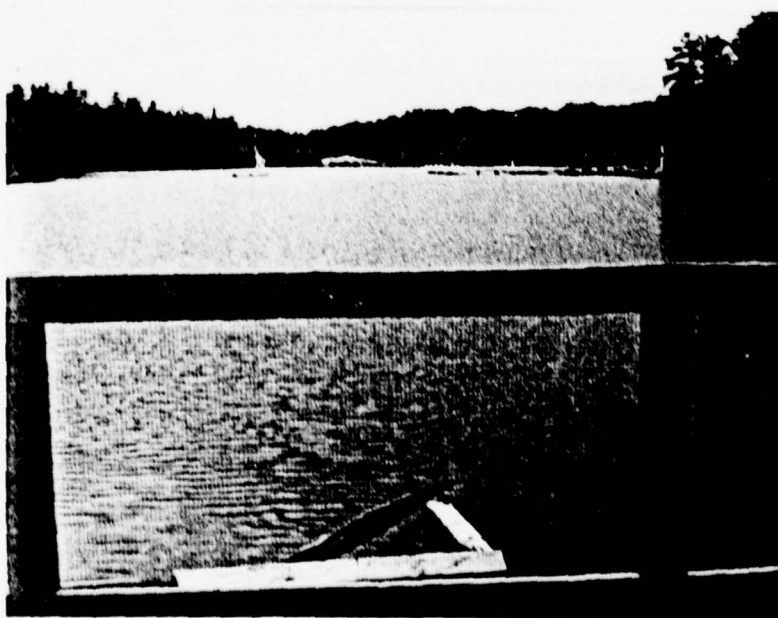
View of Lake
June 1978
